After purchasing my TRS-80 Model 4GA and working to get out up and running, I quickly discovered that several important keyboard keys weren't functioning correctly. The shift keys were displaying the I and H characters (see picture) respectively and the B, H, I, J, K, L, and N keys were all behaving erratically. Since both shift keys were not functioning correctly there weren't many commands I could carry out.

## Process Used To Repair Membrane (alps) Keyboard on TRS-80 Model 4GA

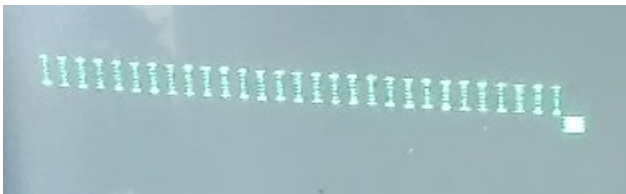
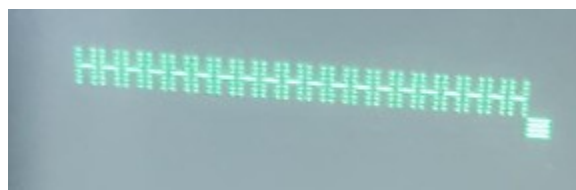
Testing all the major keys produced this set (Note how I, H, K, N, and L were always capitalized, and no B):

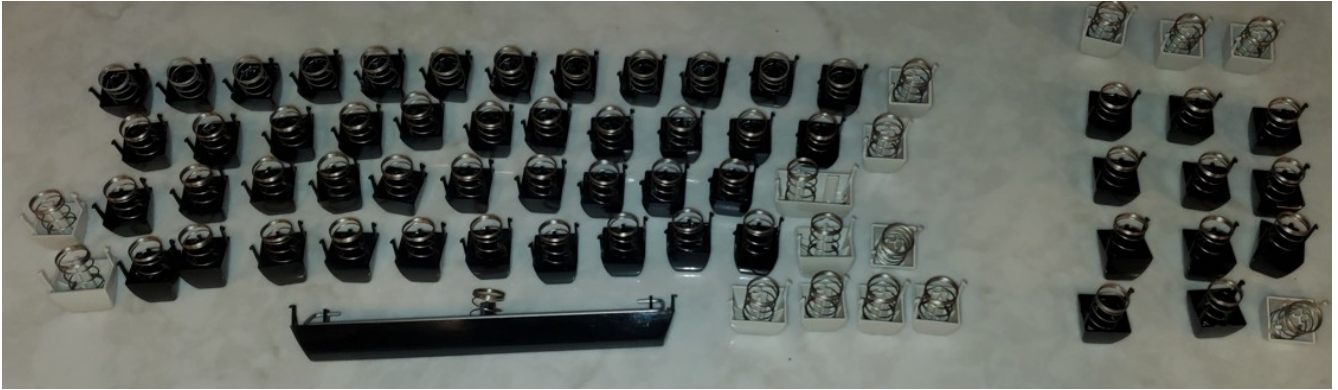
Remove all of the keys & large springs on the top-side of the keyboard. This will enable you to thoroughly wash the entire plastic keyboard structure later in the process.

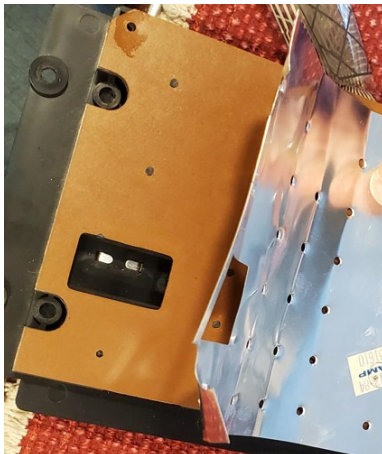
On the underside of the keyboard, gently pry off the metal foil backing. Do your best not to deform or tear it because you will need to reinstall it later!

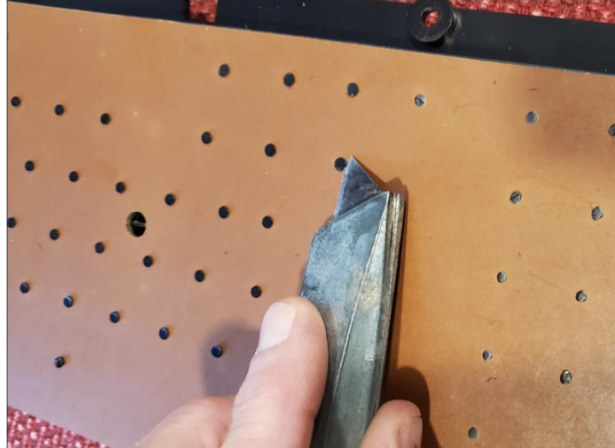
Use a box cutter knife to break off only the tips of each plastic peg (melted fasteners), and then slowly work to remove the hard "Formica-like" (e.g., circuit board material) backing plate.

Be very careful not to crack this thick plate because it's essential to supporting the keyboard membrane. Be certain all the tips are removed before attempting to remove the hard backing plate. Also go gently near the Mylar cable areas.

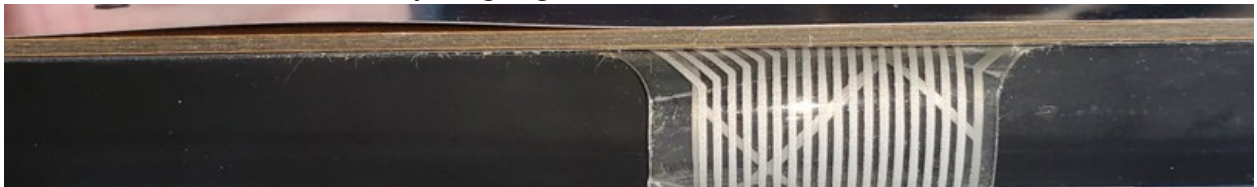
Go slowly when separating the hard backing plate so as to not break any of the plastic pegs. These are essential to hold everything together!

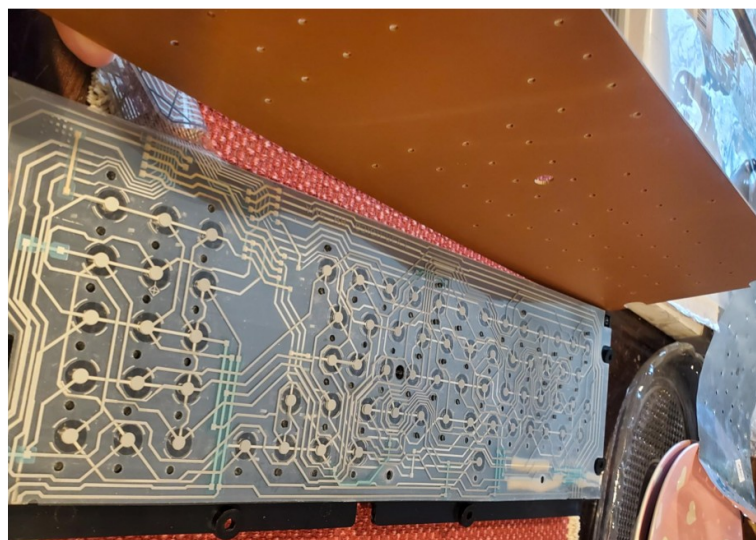
After gently removing the backing plate, remove the first membrane Mylar sheet. It's important to keep track of each Mylar sheet for correct reassembly. This first sheet has large holes around each key location which serve to provide a landing spot for each small "under key" spring (more on these later).

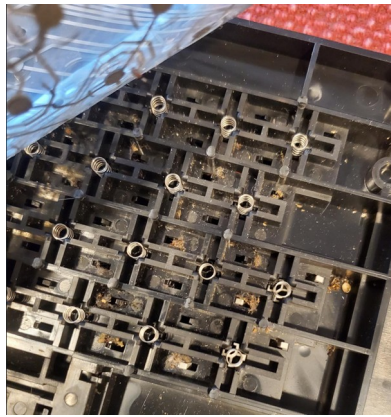
Carefully unfold the two circuit membranes. Look for contaminants (bugs, spider parts, etc.) within these membranes). Note the contaminants found in the pictured examples. Be prepared to find this in your keyboard! Gently clean the surfaces of both membranes - a product I recommend is product called Novus #2 which is a combination of a very mild abrasive and mild wax.

Membranes pulled back, revealing contaminants. Be certain not to lose any of the tiny springs inside!

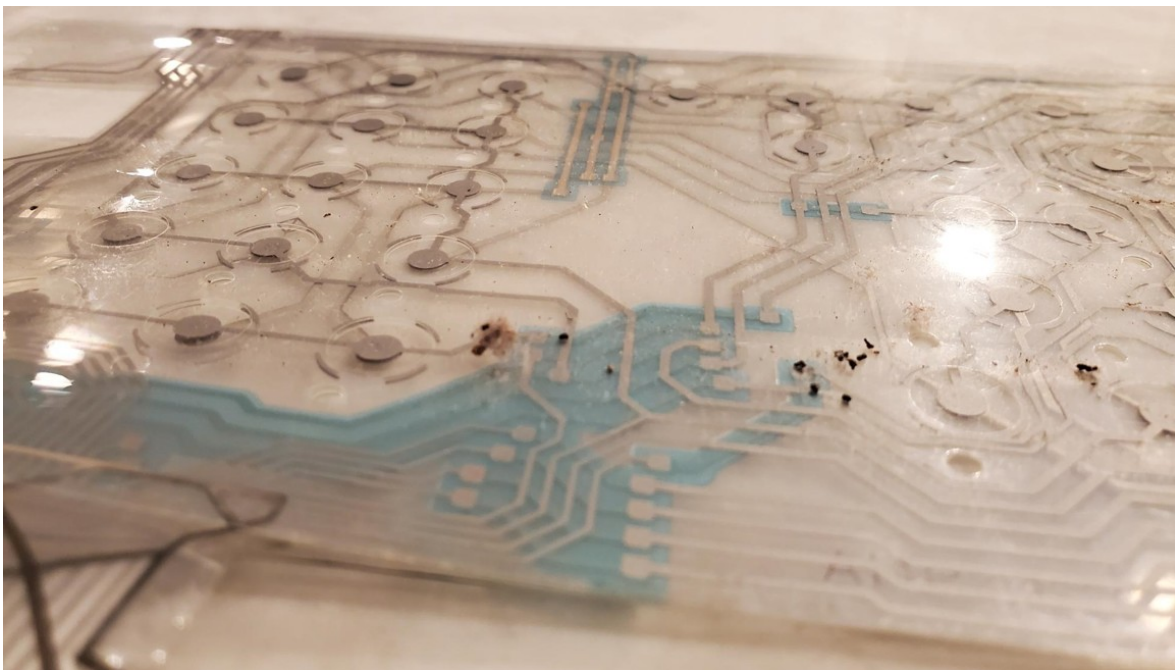
After the Mylar cleaning is done, and you've done a full inspection of all the circuit traces to ensure none were broken, close the membranes back together ensuring the spacer sheet goes back in between as it should be.

At this point, you may want to take the membrane assembly and plug the cable into your TRS-80 and test all or at least some of the primary problem keys. Do this by touching the spots on the Mylar where the key-spots make contact. Hopefully they are working now!

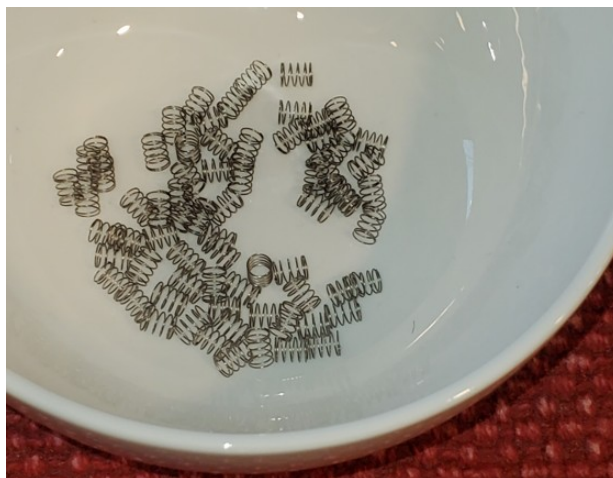
The next task is to clean the large plastic keyboard structure. Gently remove each tiny "under key" spring, making certain not to lose any of them! Consider placing them into a small bowl for safe keeping.

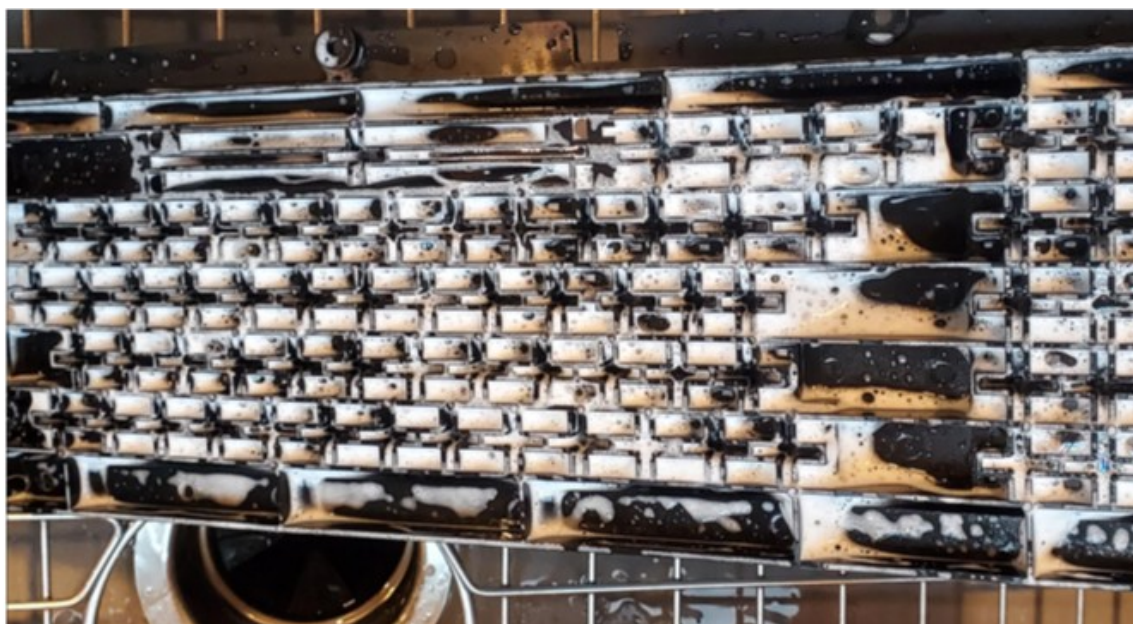
At this point, with all the tiny springs removed and safely stored, the large plastic keyboard structure is now ready for a good soap scrubbing. Used a light brush (old toothbrush) with dish washing liquid to clean all of the aforementioned junk out, and then give it a good rinse and set it out to dry.

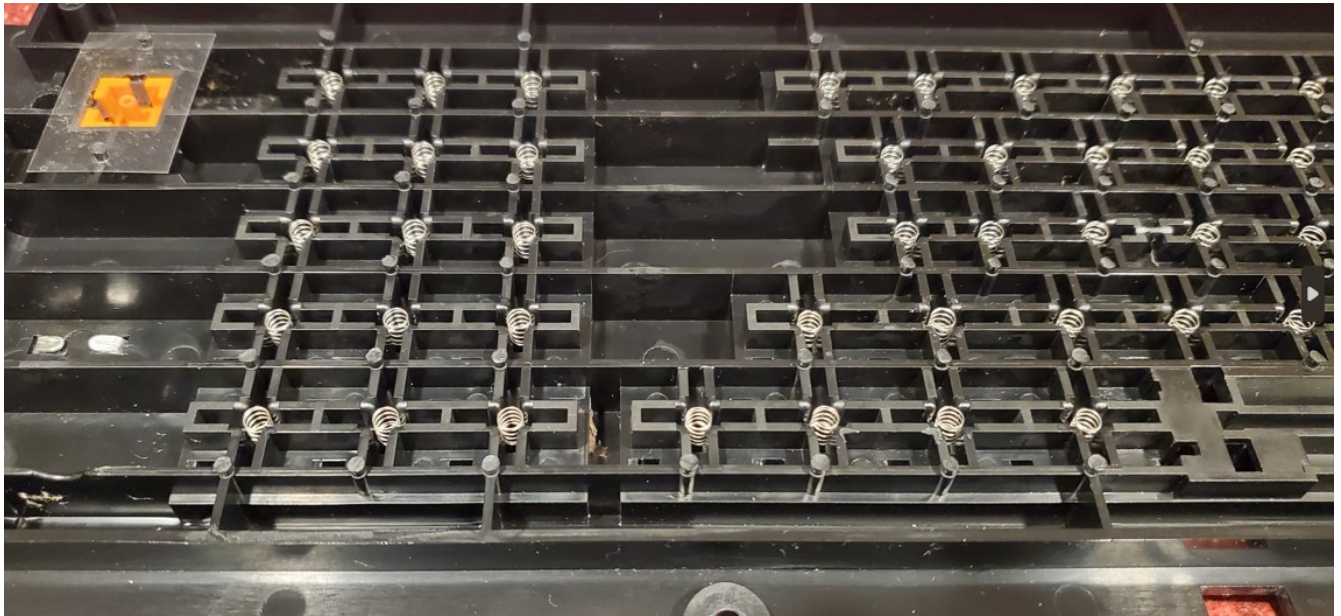
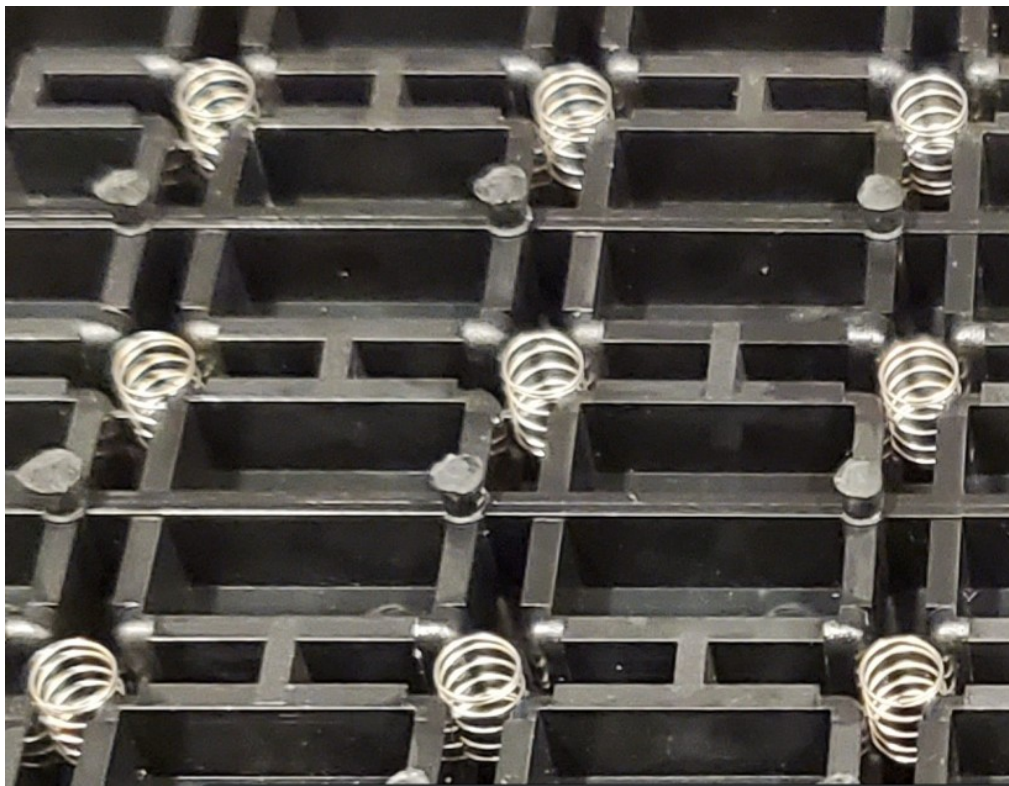
Once the keyboard structure is dry, it is time to put everything back together. Carefully replace each and every "under key" tiny spring.

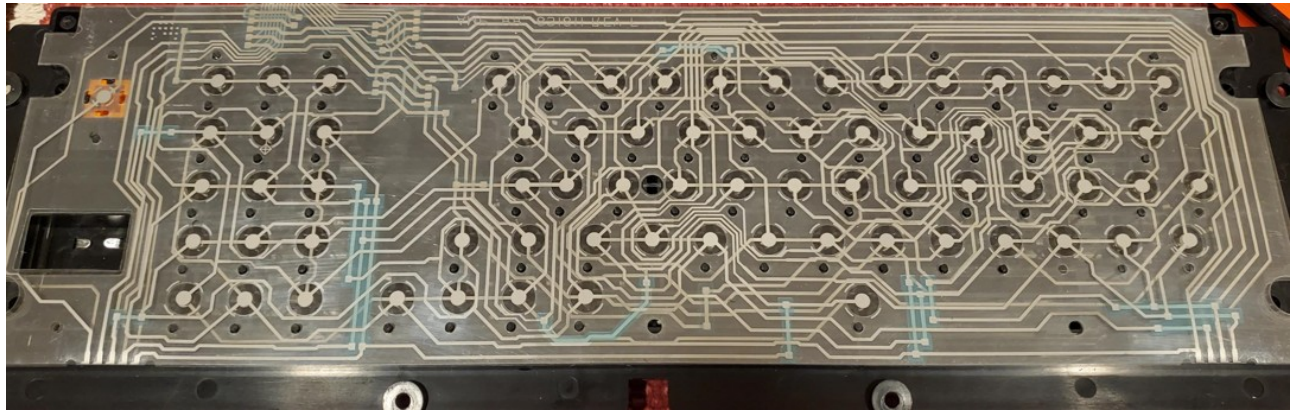
Next, align and place the membrane assembly back into the plastic keyboard structure, making certain each and every hole meets up with its corresponding plastic peg.

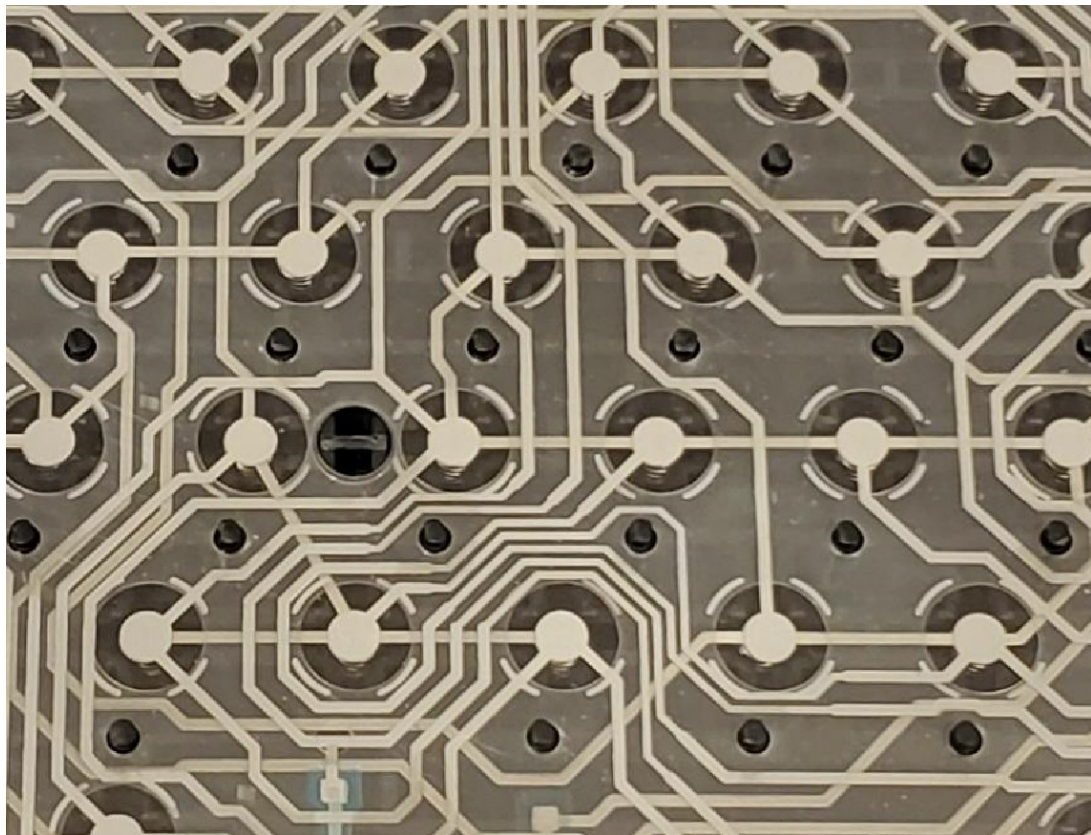
Next replace the bottom Mylar spacer sheet, ensuring to also matches up perfectly with each plastic peg.

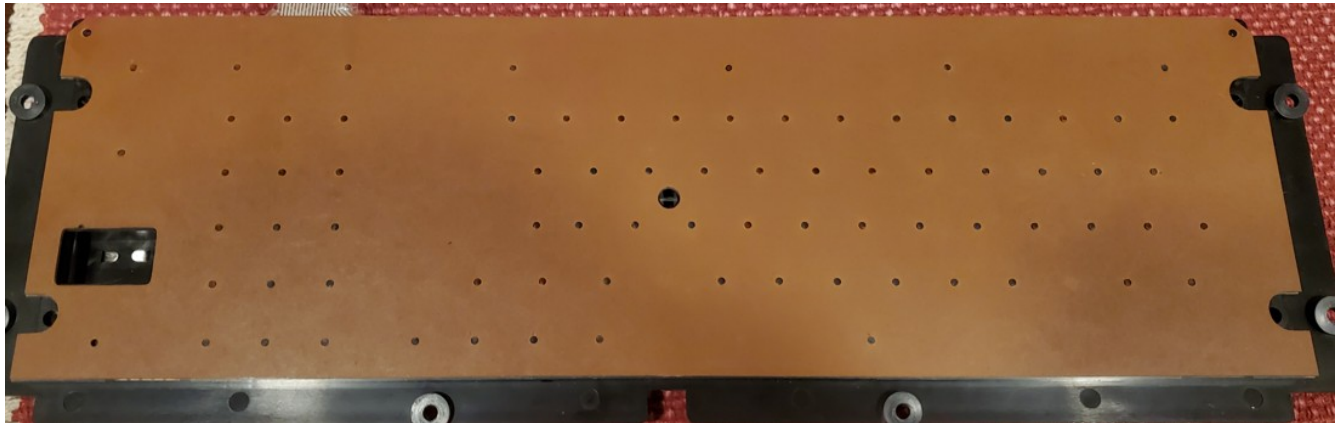
Finally, place the hard backing plate back on, aligning it to every plastic peg just like you did with the Mylar sheets.

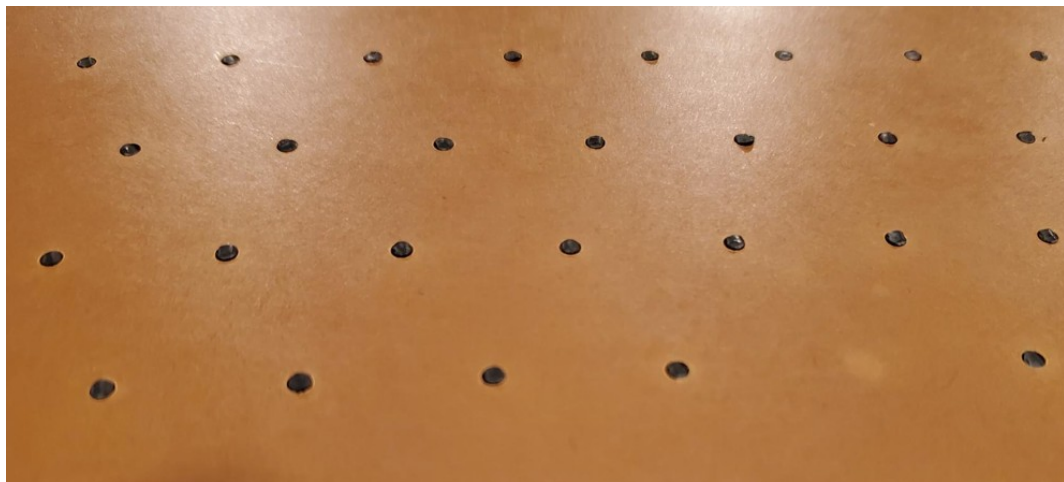
If you were careful to cut only the tips of the plastic off, the backing plate should go back on quite snugly, looking a lot like this picture.

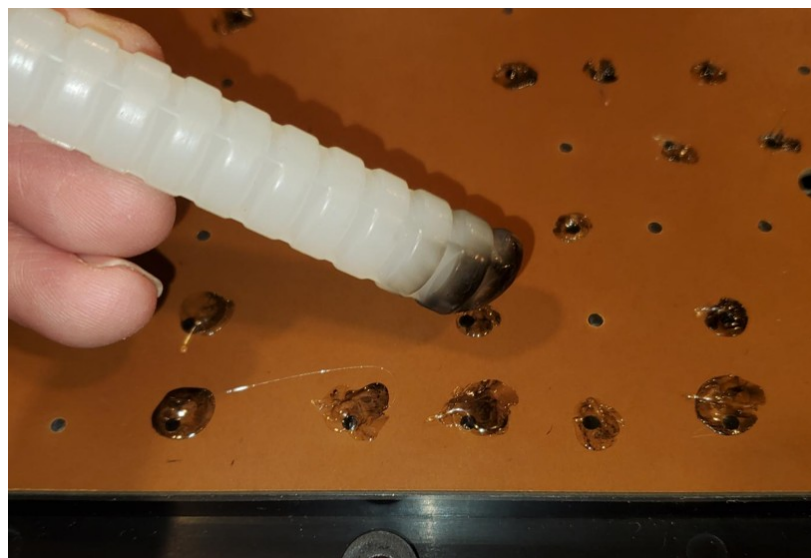
Add the foil backing plate in the same manner, and use a glue stick as a replacement way to add back the plastic tips.

Make certain you to replace the metal foil under the keyboard because it's used as a ground strap across the computer. Don't worry about how it looks, just make sure it functions electrically as it was designed to do.
